Manhole Inspection Summary

Manhole # S23CC1040MH

Insp Date: **6/27/07 10:27 AM**

Location Address: **1619 UNION AVE**

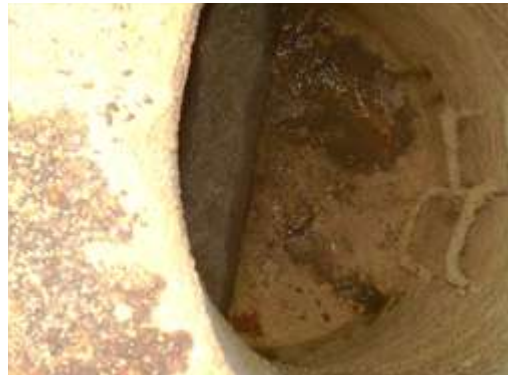
Top View

Bench ☒ Exists Material: **Brick** ☐ Parged ☒ **Debris** (not Condition related)

Bench debris.

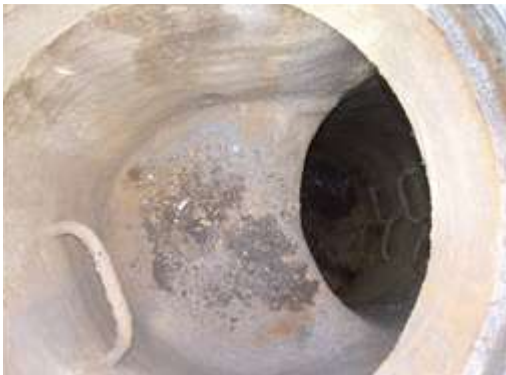
Defect

Infiltration: ☐ None ☒ **Joint** ☐ Cracks ☐ Mortar ☐ Roots ☒ **Wall**

Infiltration: ☐ None ☐ Joint ☐ Cracks ☐ Mortar ☐ Roots ☒ **Wall**

Adjustment and Barrel infiltration.

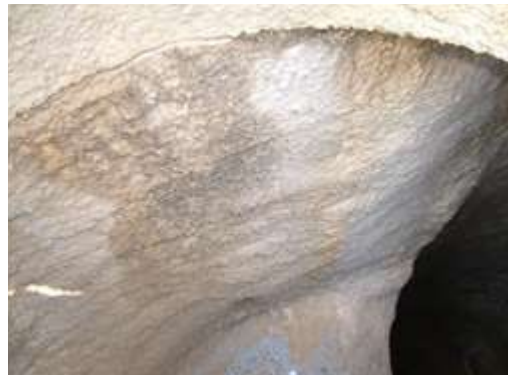
Defect

Adjustment infiltration.
